桜川市真壁町上谷貝

鹿島神社本殿

1月20日 木部の修理が
終わりました

【第4回】 今回の修理で確認された墨書

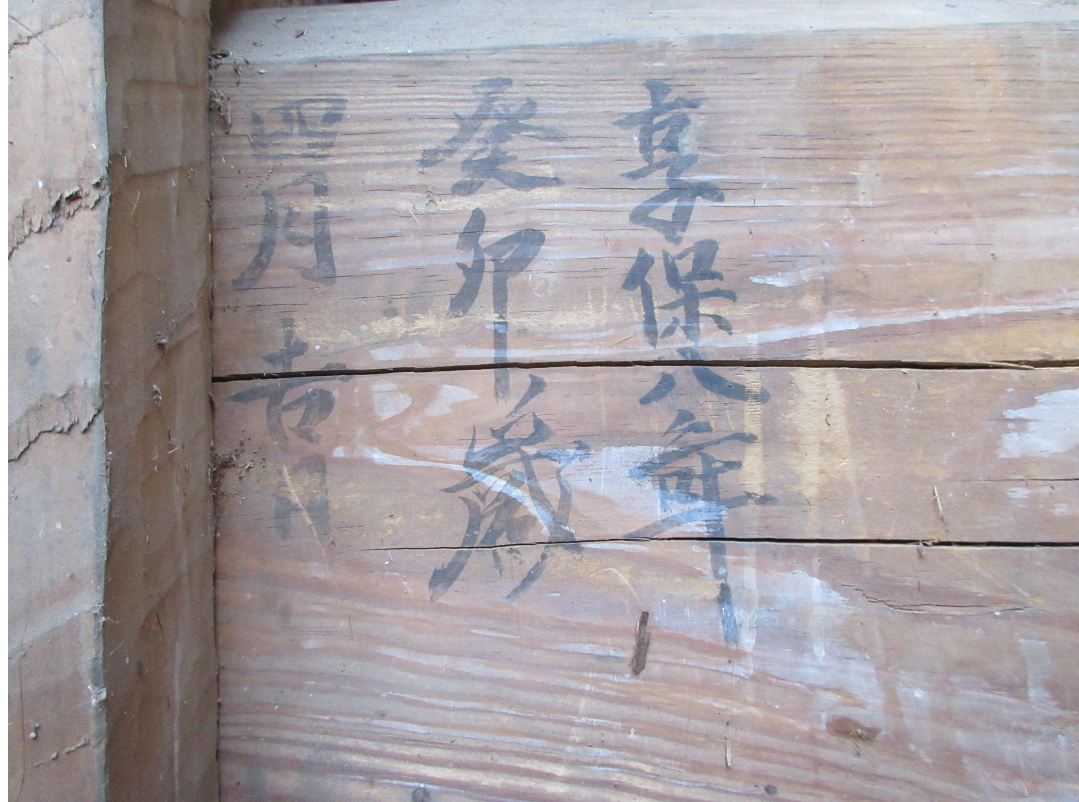
（棟木中央南面）

今回は茅を全て下ろしたので、内部がよく見えるようになりました。棟木の中央に享保8年(1723)4月の墨書がありました。同年11月の棟札が残っていますので、4月に棟上げをして、11月に完成ということでしょうか。

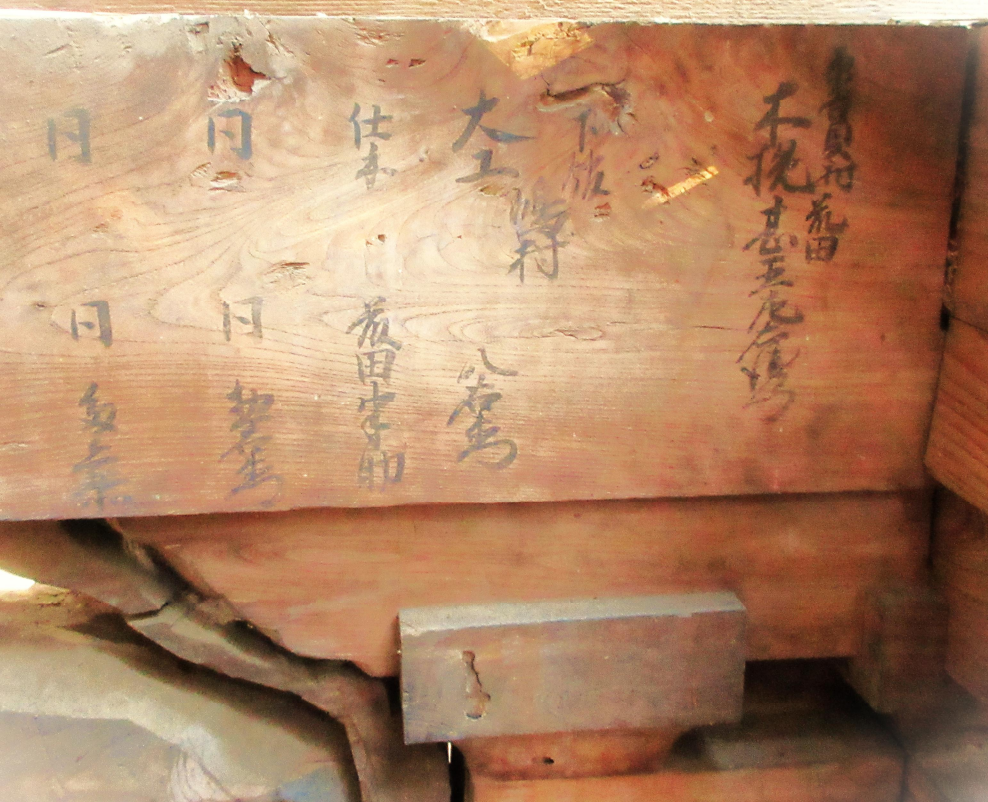
（東面内側 二重虹梁）

二重虹梁の内側には、大工や木挽の名前がありました。棟札と同じで、大工は棟梁が下館の島村（養蚕小学校の南）の杉山八右衛門、仕手（棟梁の下で働く大工）が上谷貝の藤田半助、惣右衛門、多兵衛、木挽が原方の藤田甚五左衛門です。

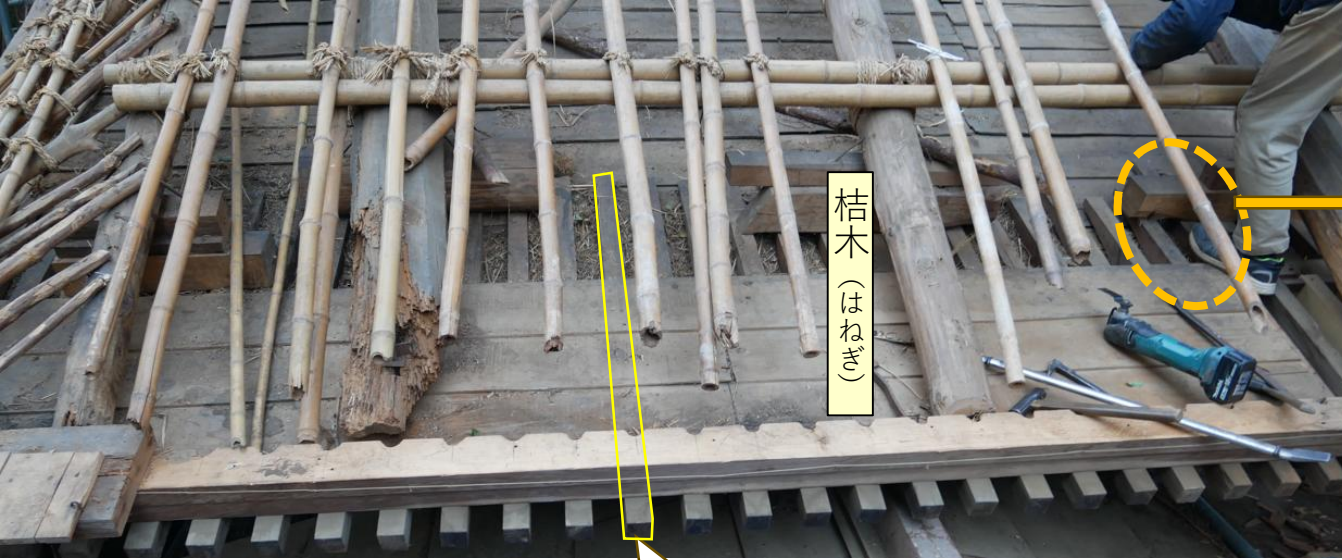
桔木 (はねぎ)

木を撤去したところ、傾いていた神社の建物はまっすぐに戻ったのですが、屋根の穴はもちろん直りません。茅を下ろすと、桔木（はねぎ）が横にずれ、野地板に穴が開き、飛檐垂木（ひえんだるき）が2本折れていました。今回、これも修理しました。

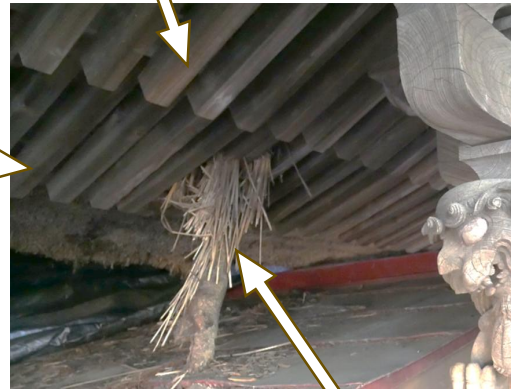
今回は茅葺きの葺き替え時期が近付いていて準備を始めていたのですが、令和6年3月末の暴風で、鹿島神社の本殿に境内の木が倒れて屋根を傷め、枝は屋根を突き破ってしまいました。

倒木の枝が屋根を貫通し垂木も破損

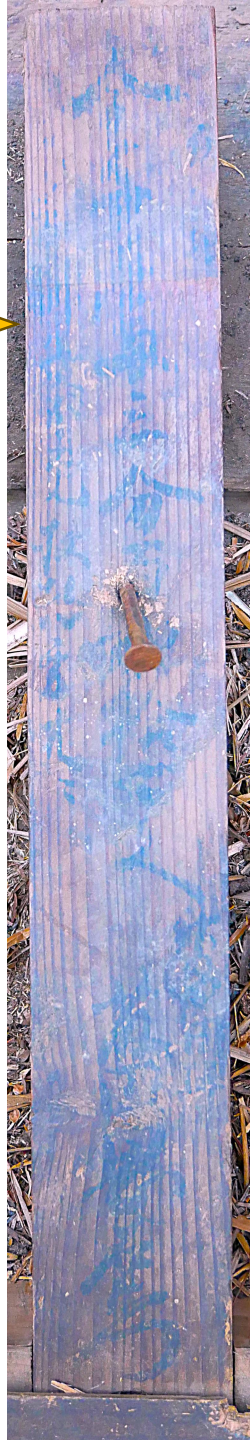
折れた部分のすぐ脇の垂木2本を見ると、墨書がありました。1本は殆ど読み取れないのですが、もう1本には修理の費用や人数、名前などが書いてありました。

地垂木（じだるき）の上に飛檐垂木（ひえんだるき）を乗せて屋根を反らしながら伸ばしている。その飛檐垂木に墨書が発見された。屋根修理に要した費用と延べ人数を記している。

「一」 金子□両三分百貳拾四人 中谷田坪
「一」 扶持方共二 藤田岡右衛門
