桜川市真壁町上谷貝

鹿島神社本殿

1月20日 木部の修理が
終わりました

【第4回】 今回の修理で確認された墨書

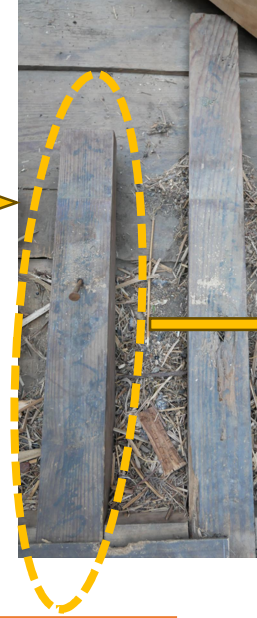
飛檐垂木

木を撤去したところ、傾いていた神社の建物はまっすぐに戻ったのですが、屋根の穴はもちろん直りません。茅を下ろすと、桔木（はねぎ）が横にずれ、野地板に穴が開き、飛檐垂木（ひえんだるき）が2本折れていました。今回、これも修理しました。

倒木の枝が屋根を貫通し垂木も破損
